USING THE ASHRAE 110 TEST AS A TQM TOOL TO IMPROVE LABORATORY FUME HOOD PERFORMANCE

February 13, 1997

Dale T. Hitchings, PE, CIH
Hitchings Associates, PC
Indianapolis, Indiana

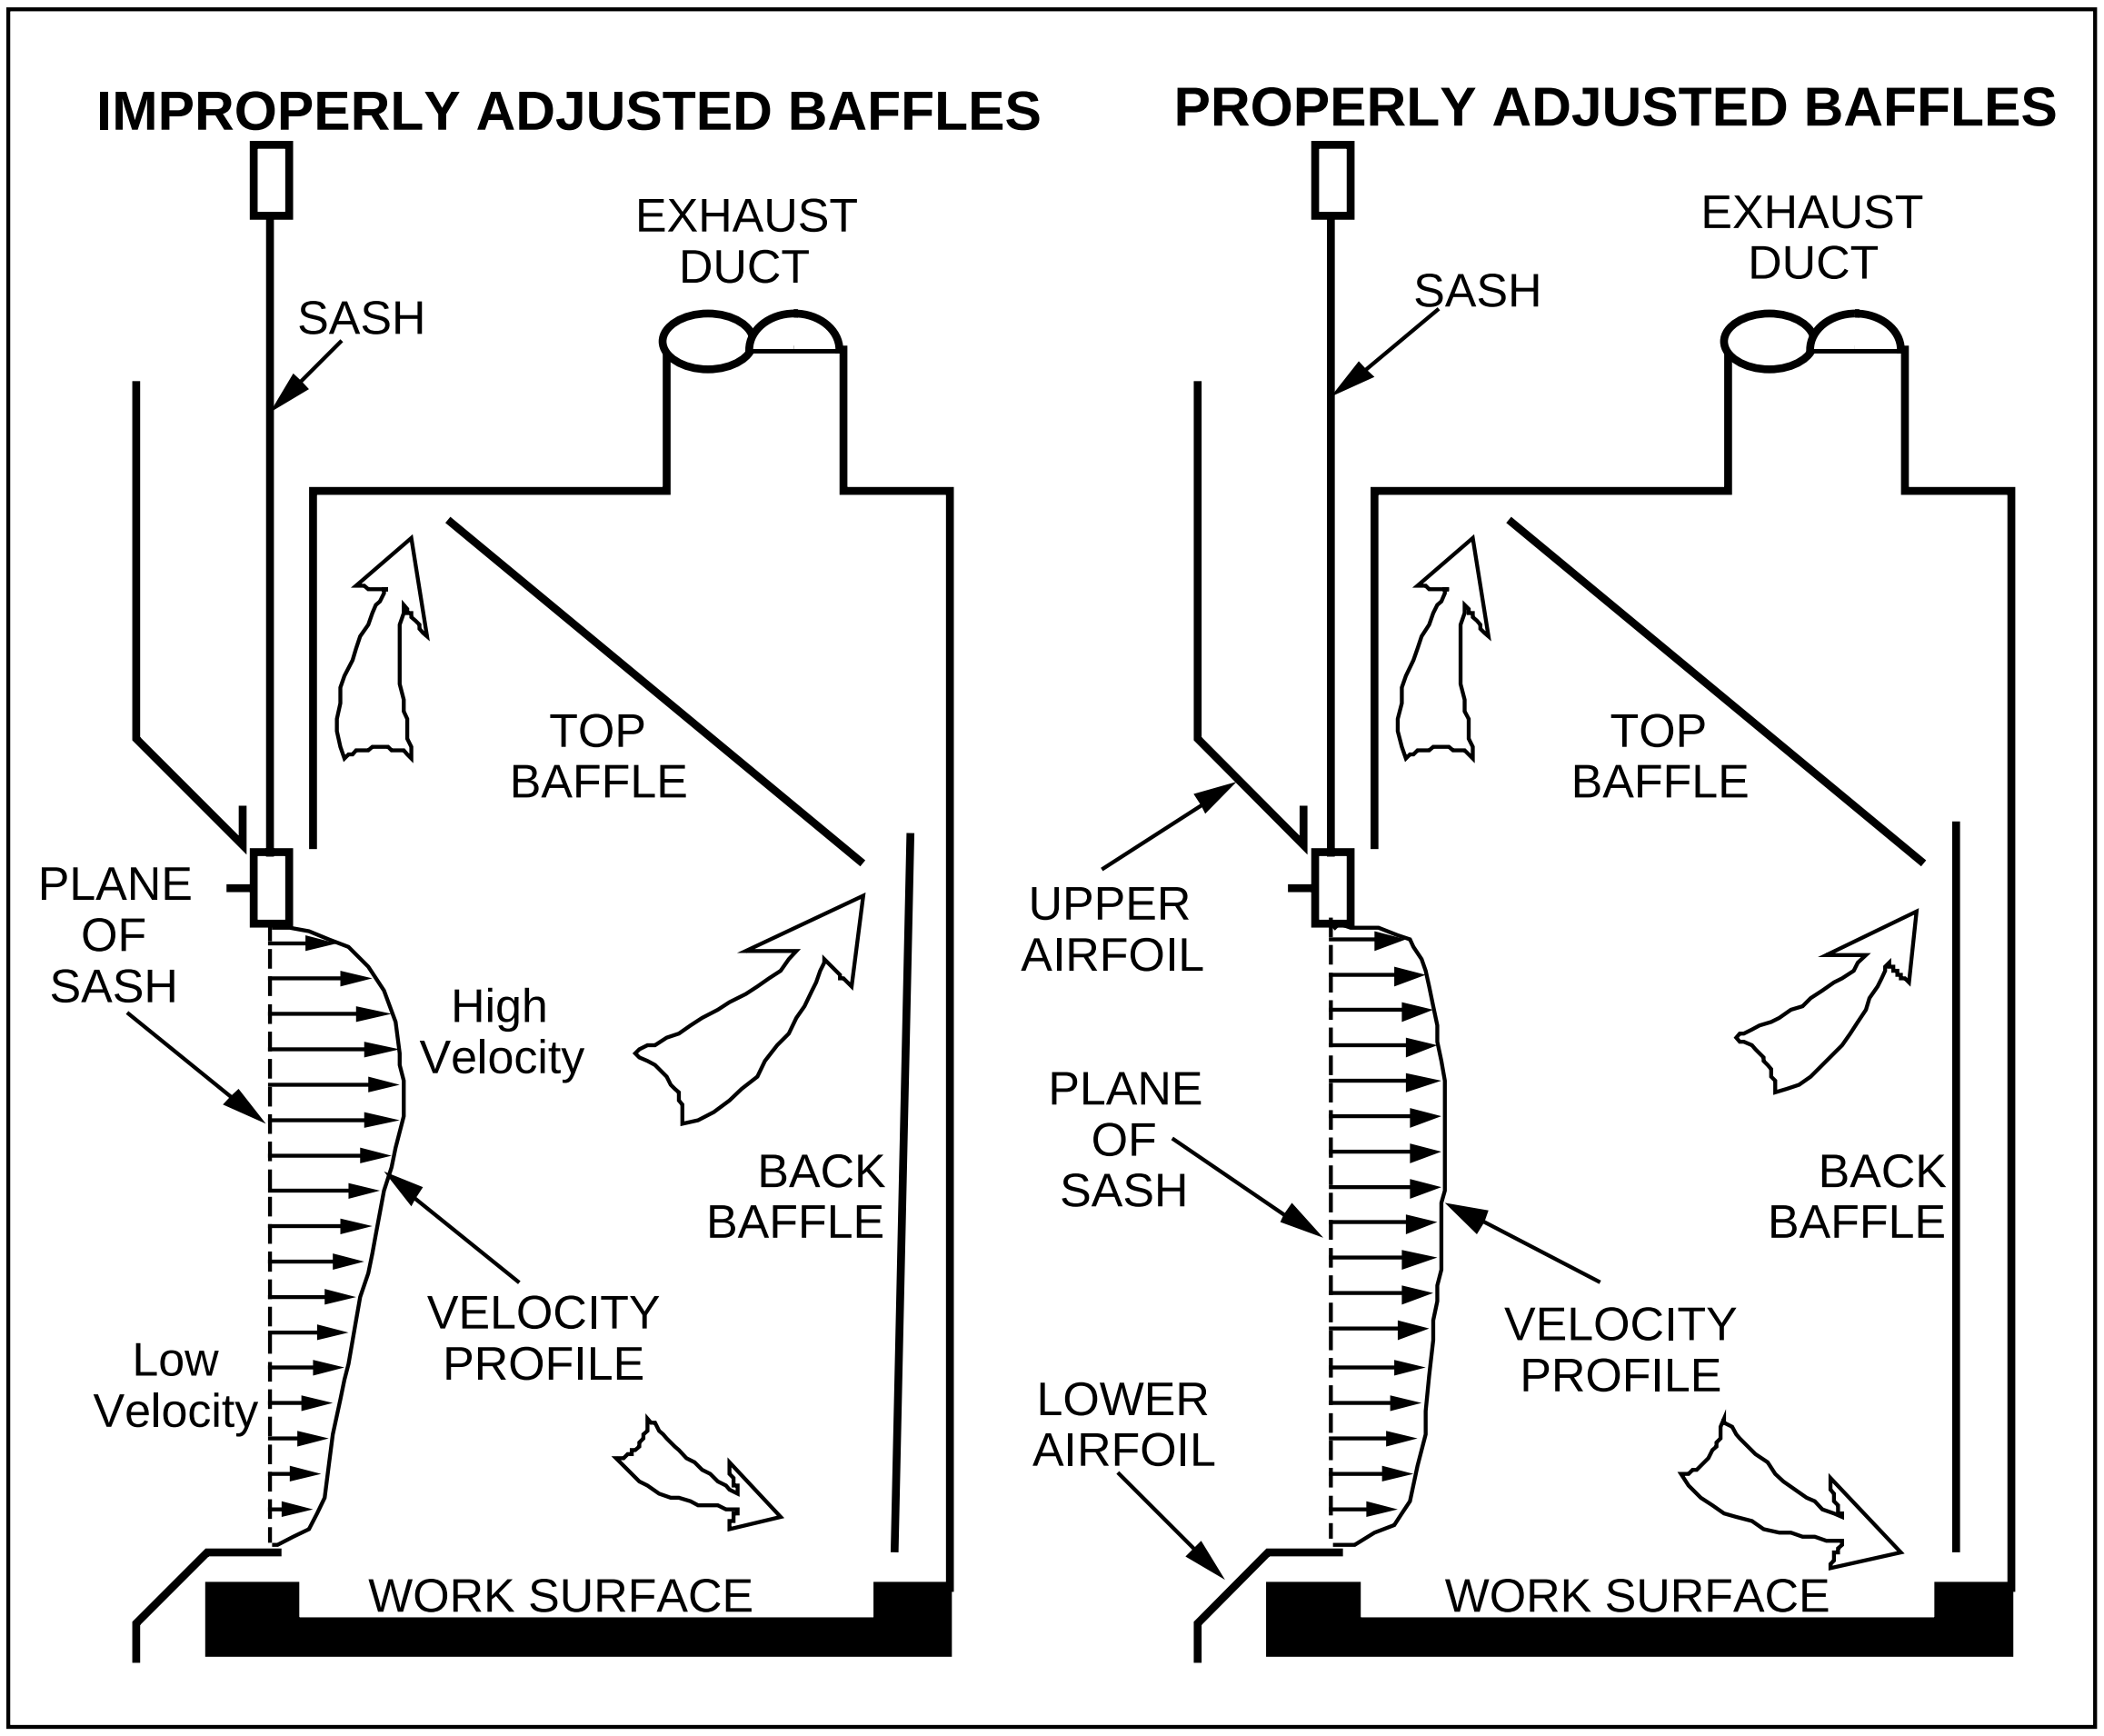
Figure 3: Baffle Optimization

Hood baffle optimizations: The baffles on most of the hoods tested were improperly adjusted and exhibited much higher velocity at the top of the opening than near the bottom. Adjustments were made to optimize the profile. (see Figure 3.)

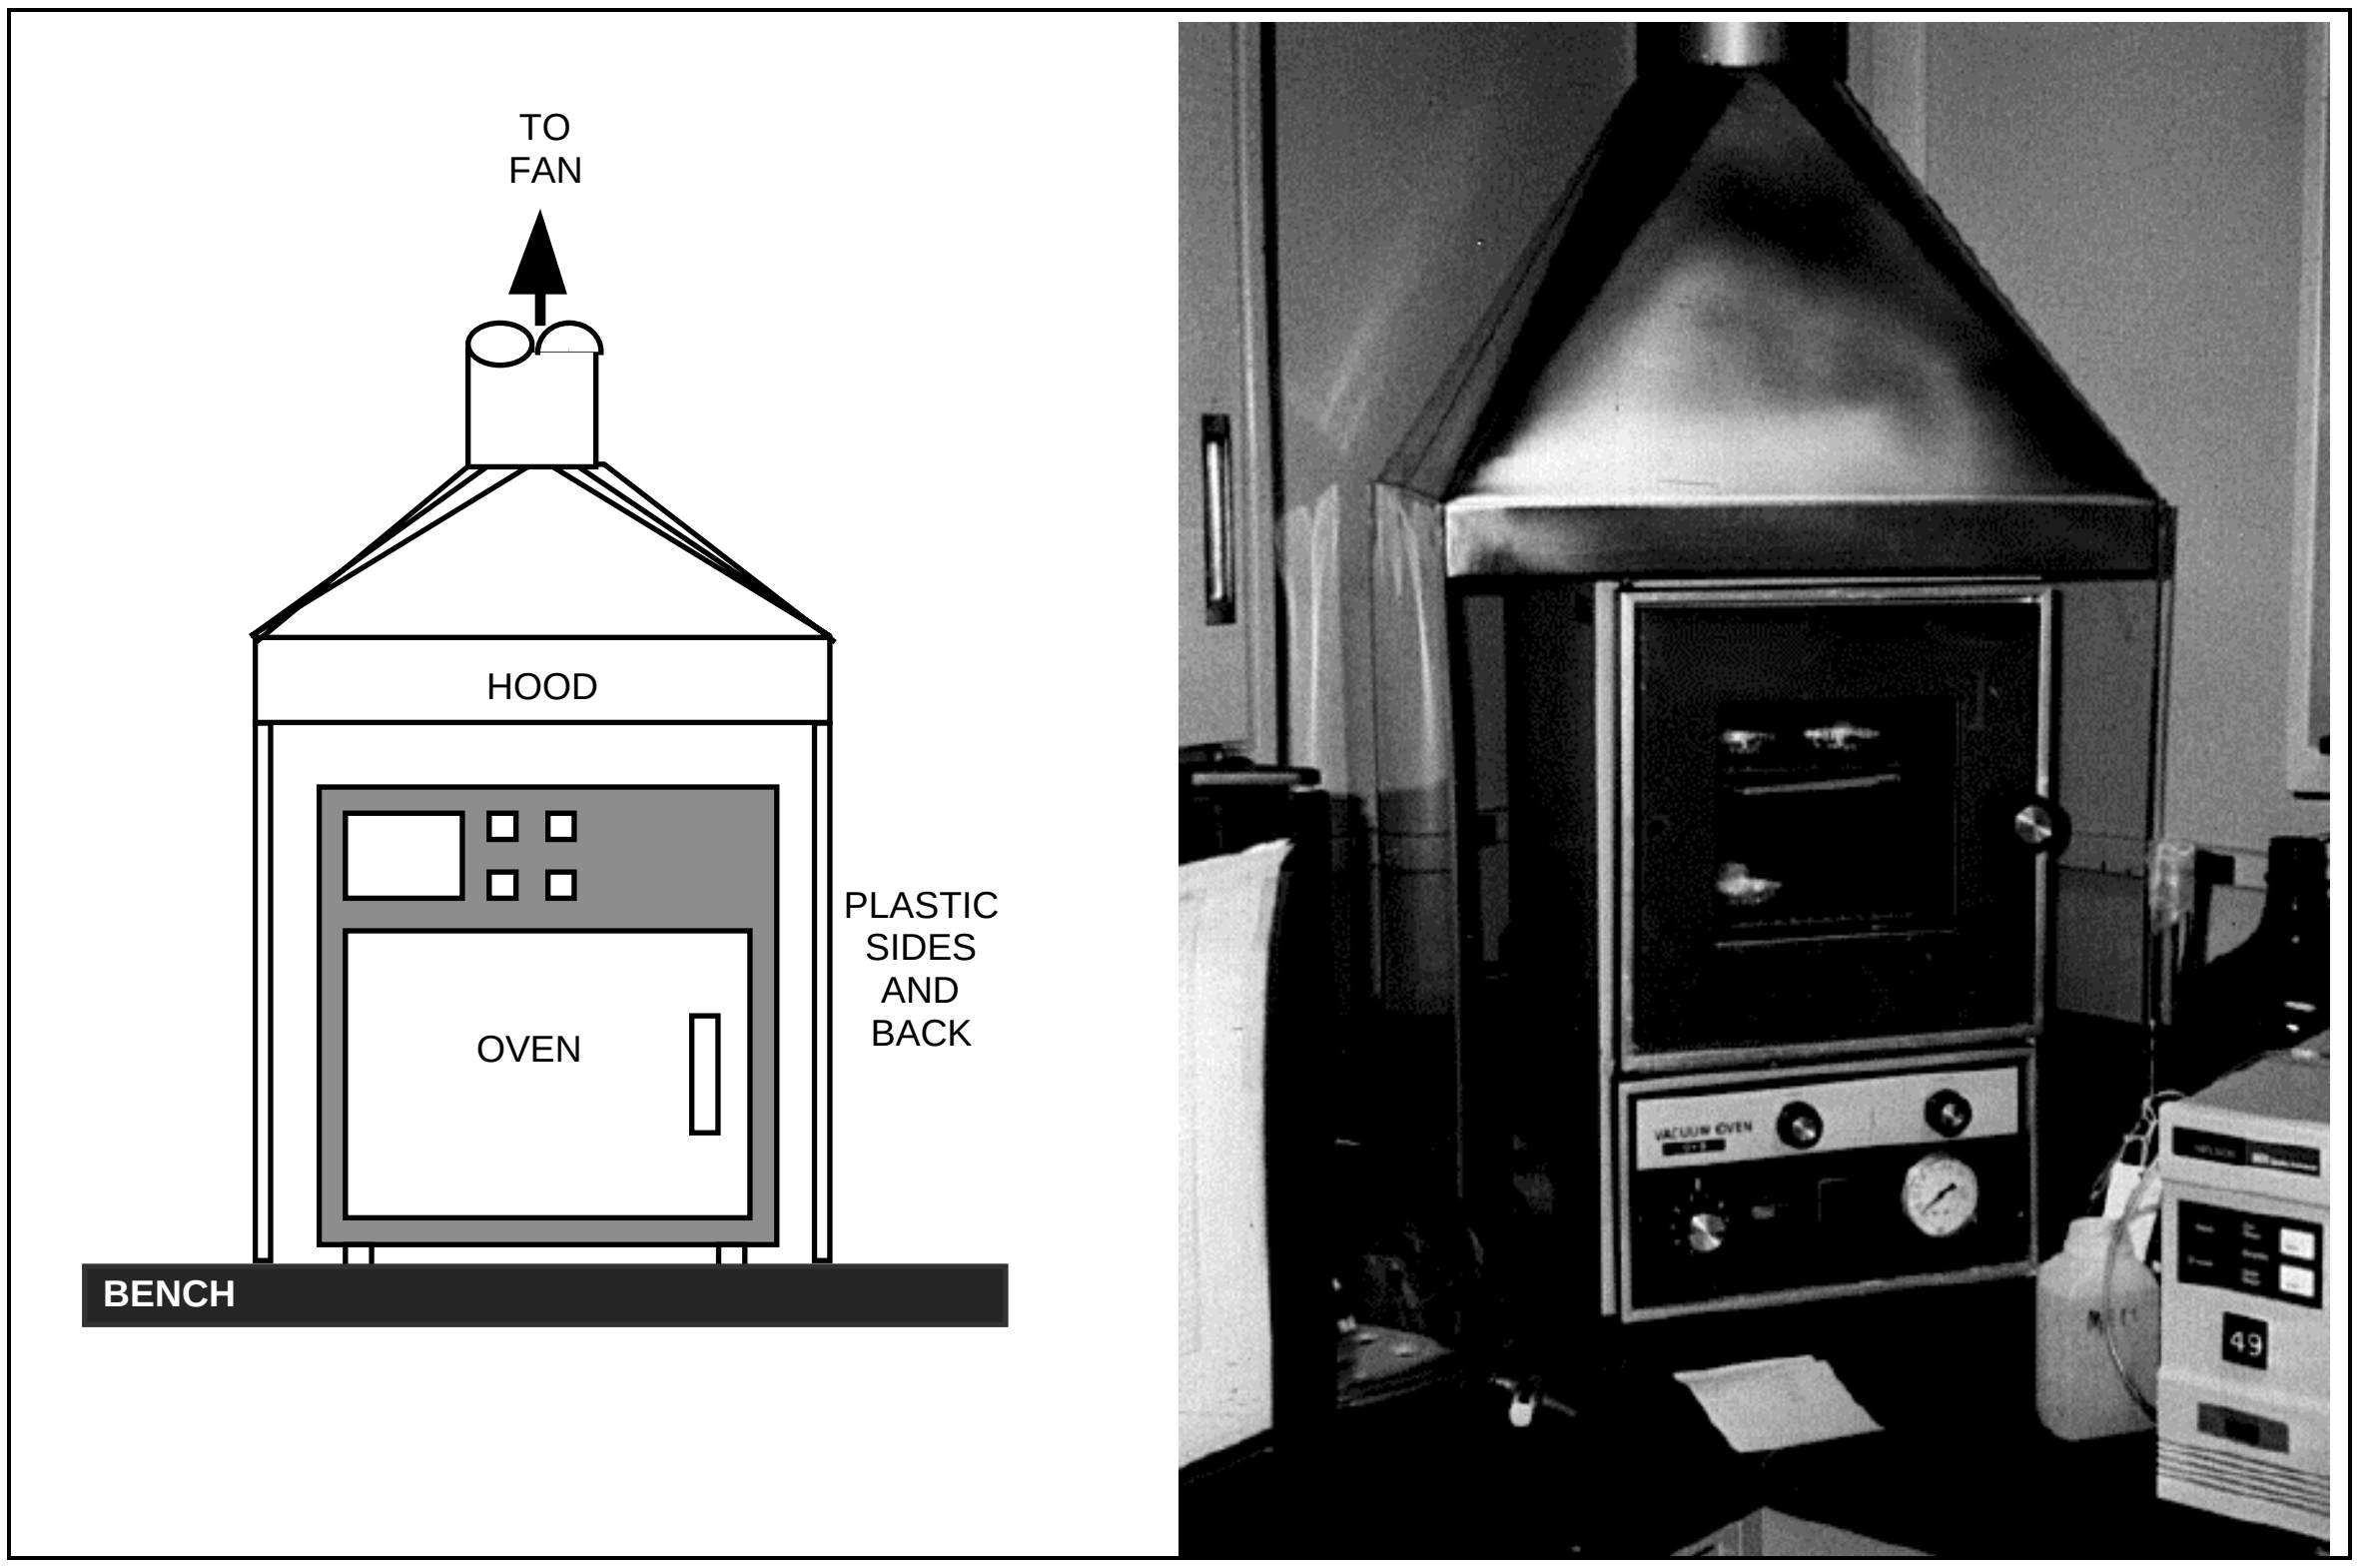
Figure 5 Typical Oven Hood

Installation of specific exhausts: Several hoods had large pieces of equipment in them which were blocking airflow into the hood and impairing performance. These were removed from the hoods and placed on the benchtops nearby. Special exhaust systems were designed and installed to ventilate each piece of equipment. Figure 5. shows a typical booth type hood suitable for a lab oven. Figure 6. shows the method used for ventilating gas chromatographs. Figure 7. shows the method used for ventilating an atomic absorption spectrophotometer (A-A Spec).

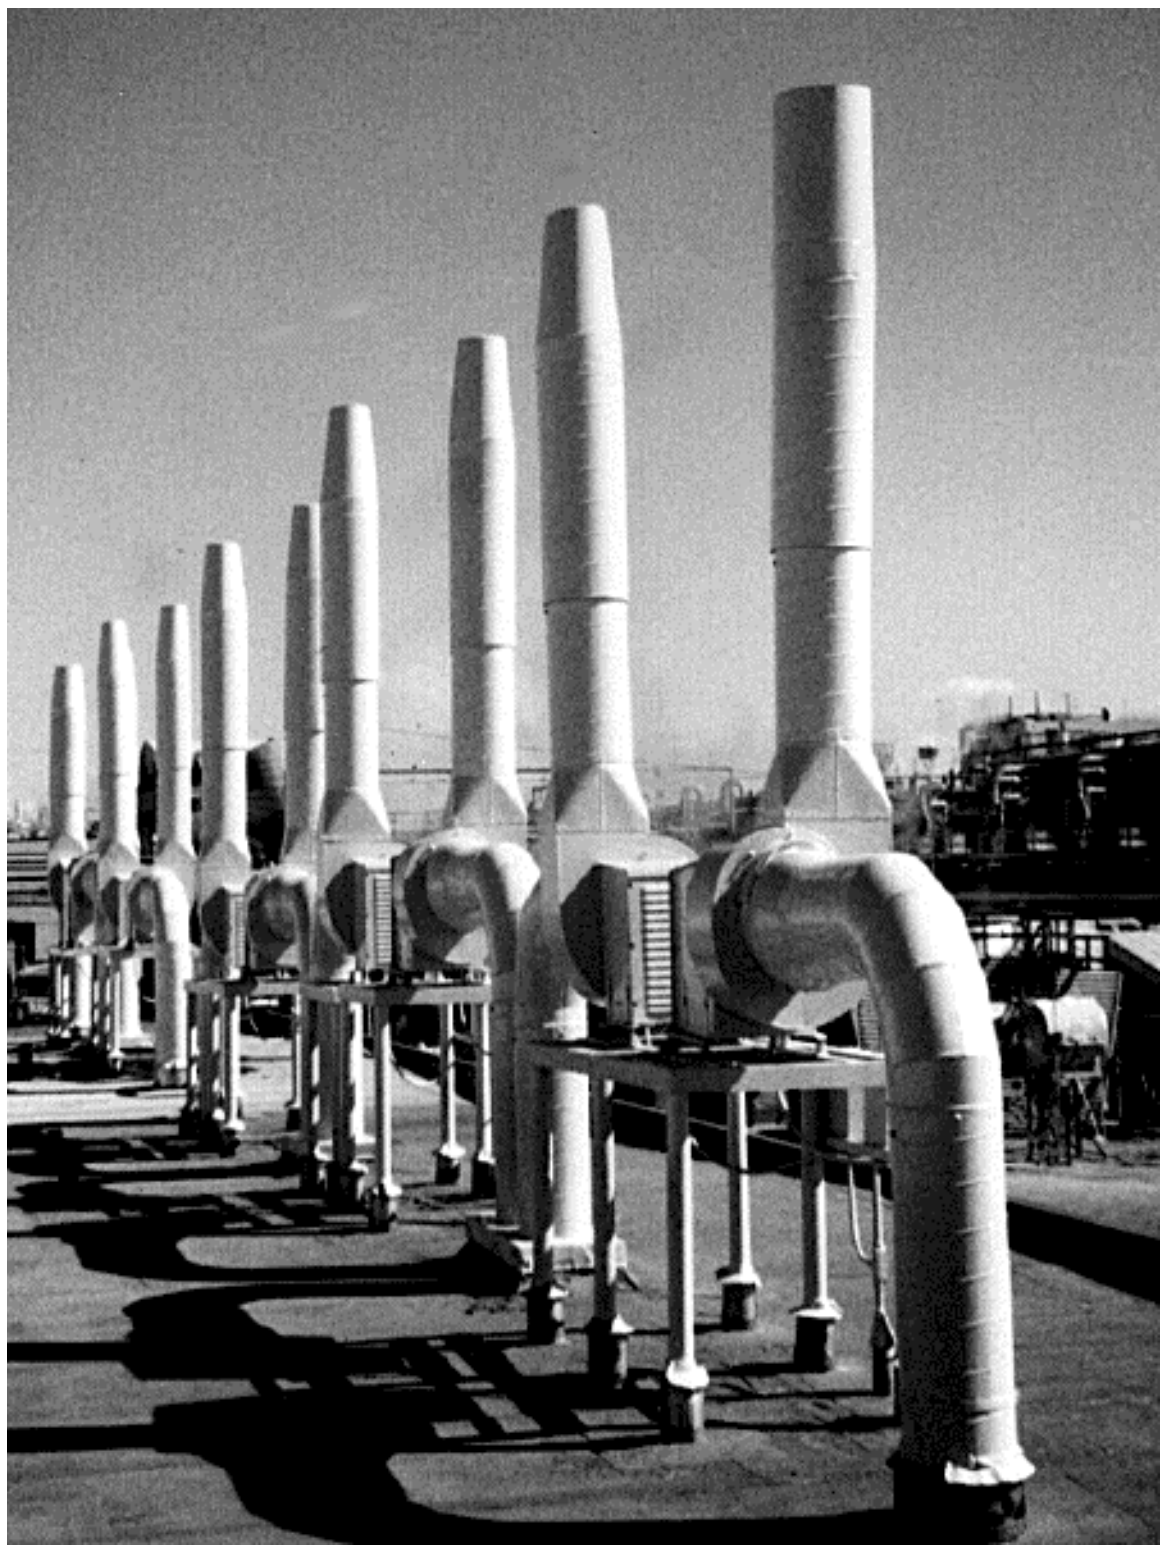
Figure 9 Exhaust Stack Enhancements

Exhaust stack enhancements: Reingestion of contaminated air back into the building supply air was occurring. Exhaust stack heights and discharge velocities were increased using nozzles attached the top of the stacks. (see Figure 9.) Note that this is not normally a good design practice for an initial installation but is acceptable for a retrofit application such as this.
